## Application: Tap Changer

*ISOPur Fluid Technologies eliminates carbon buildup in transformer oil and greatly reduces oil turn-over, saving the company man-hours and money*

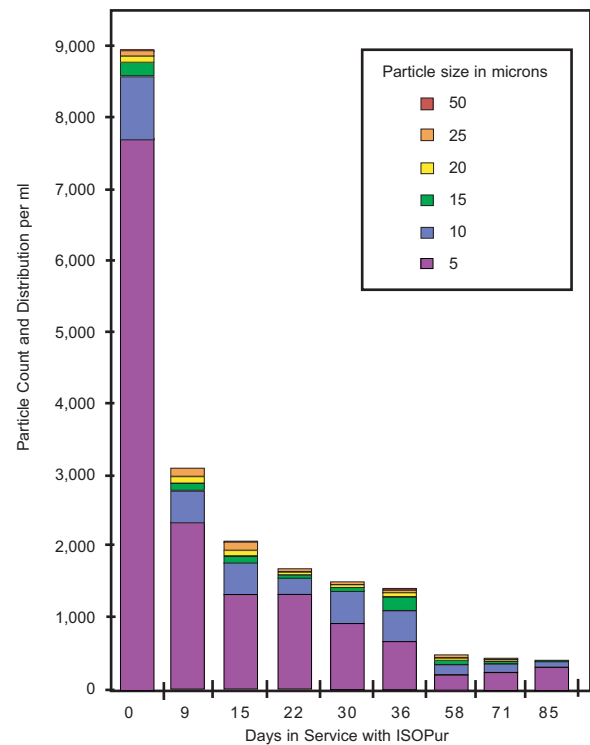
Graph 1: Past Transformer Oil Analysis

Tests were conducted using ISOPur Balanced Charge Purification (BCP) technology. The oil analysis results are displayed in Graph 1.

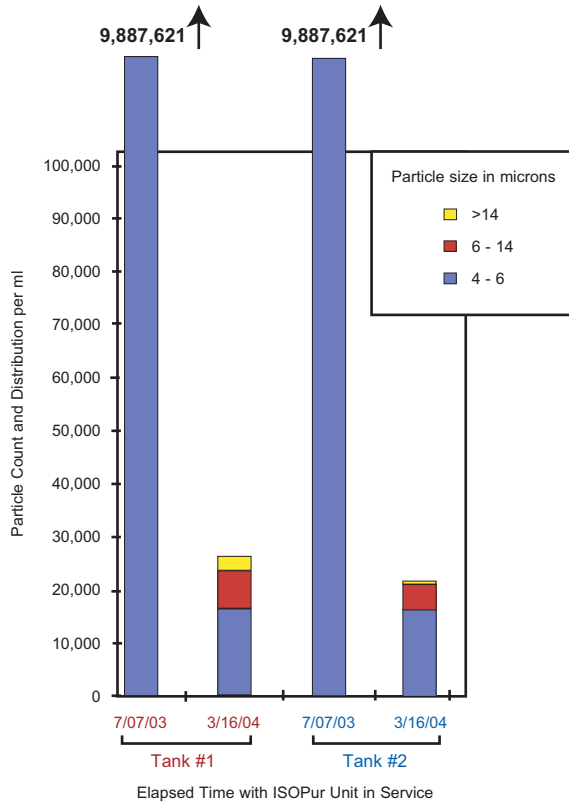
Graph 2: Con Ed Transformer Oil Tank Analysis

Tanks 1 and 2 oil samples were taken at installation and again nine months later. Graph 2 shows the positive effect on the carbon contamination as well as on the entire transformer oil system.

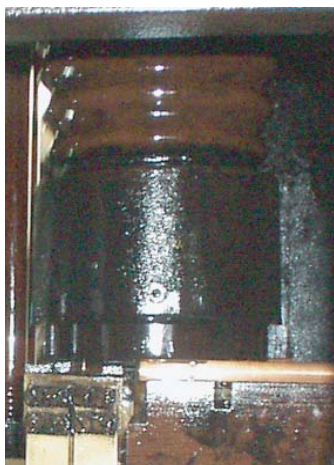
Figure 1: Before ISOPur (taken 04/03)

Con Edison was experiencing carbon buildup on the glass insulators as well as the copper contact points in two of their tap changers. The contamination caused arcing and reduced dielectric KV levels, creating an unstable environment within the fluid. As the transformer oil became heavily contaminated, the insulation was reduced causing erosive wear and dangerous short circuiting.

Figures 1 & 2 exhibit a comparison of the tap changer application at Con Edison. The ISOPur I-50 units were installed in June of 2003. Figure 1 is the tap changer before the Balanced Charge Purification (BCP) technology was implemented. Note the carbon and sludge found on the base and on the screw plate contact points.

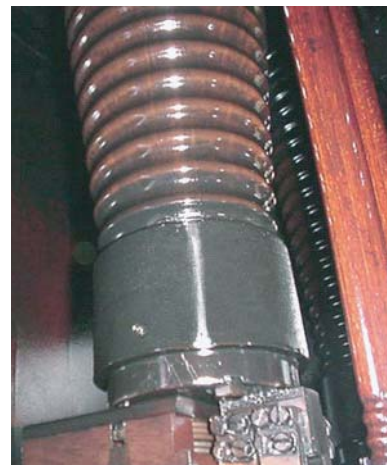
Figure 2: After ISOPur (taken 04/04)

When the tap changers were opened for servicing, there was visible evidence of a significant reduction of carbon buildup on the glass insulators and, more importantly on the contact points (see Figures 1 & 2).

Figure 2 is the tap changer after 10 months of continual oil purification with the ISOPur system. Note the clean appearance and removal of carbon contamination. Sludge has also been removed from the contact points, leaving them scoured and shiny.
