SISTEMAS CENTRALES DE LUBRIFICACION S.A. DE C.V.

Subject: Results of the tribological improvements made in the Industrial Paper Machine #4 during operation and scheduled shut-down.

We would herewith like to submit for your analysis the report on the **Improvement of the Production Reliability for the Industrial Paper #4 Machine** through the packet of Tribological solutions designed and executed by SICELUB.

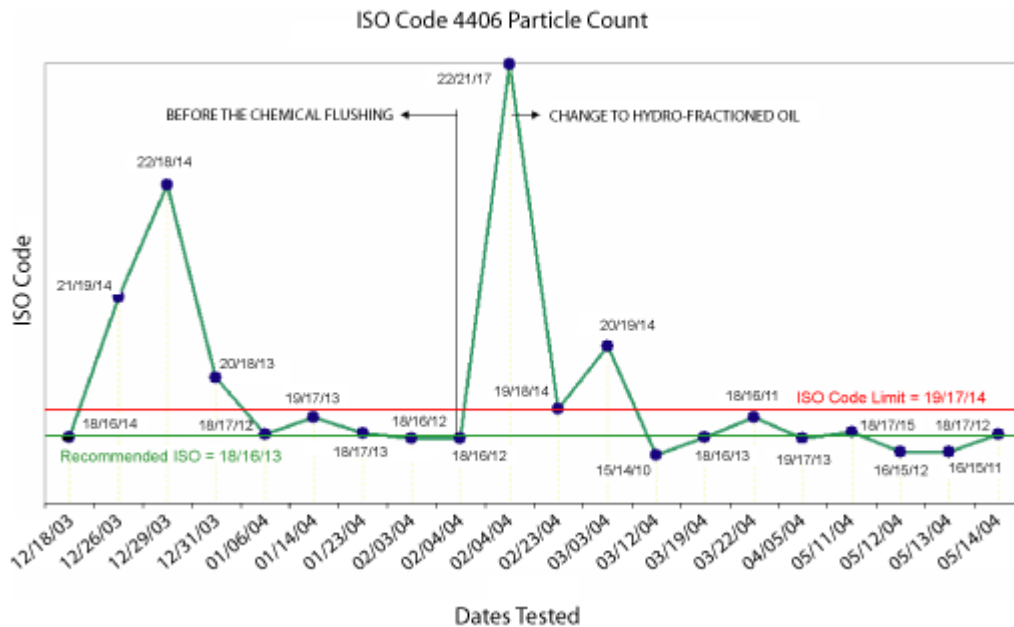
Graph 1 – Particle Count ISO Code 4460

In order to monitor the degree of oil contamination, we usually quantify the content of particles/ml of oil and then code it according to what is established in the ISO 4406 norm. This way we are able to know the cleanliness conditions of the oil and how far we are from the recommended for each application. The recommended ISO code in the case of the paper machines is 18/16/13 and 19/17/14 as the critical alarm value.

Analyzing the tendency shown on the subsequent analysis, we observe that in some days after the ISOPur equipment was connected, the values of the cleanliness code increased considerably. This was the result of the ISOPur system beginning the removal of varnish from the interior of the system. Following the tendency one can see that the ISOPur equipment rapidly removed these particles from the system and the values of the ISO code returned to low levels.

We also observe some oscillations of the values of code between the Critical and Normal limits. This is also due the system removing particles from the equipment. Note that it is always below the critical limit and the tendency is always decreasing below the recommended limit (18/16/13).

We can also observe in Graph 1 that an oil sample taken this same day, a few minutes after adding the solvent as the oil begins to recycle, the ISO code is 18/16/12. This is lower than the recommended code, thus confirming that the oil was cleaned as a result of the advanced performance of the ISOPur equipment.

After 12 hours of recirculation with the solvent and oil combination, the used oil was removed and replaced with hydro fractionated oil. The system was started and once it reached the working temperature, an oil sample was taken. In Graph 1, the sample analysis indicates a high ISO code: 22/21/17, a result of the cleaning action of the solvent.

The performance of the ISOPur equipment can be seen on Graph 1. In just a few days the equipment removed the contamination that had not been collected by the system previously due to its low efficiency and low retention power (15 μ m). The cleanliness code returned to normal values in a short period of time.

There is also proof of a certain oscillation in the value of the cleaning codes in the days after the chemical cleaning until the system stabilized. This is a result of the circulating fluid inside the system caused by the chemical cleaning. This also makes up part of the operation of the ISOPur equipment that constantly eliminates particles by performing removal cycles.

Even with the fluctuating ISO codes, they always remain below the danger zone and with a decreasing tendency to cleaning values below the recommended, providing an operation free of problems and worries.

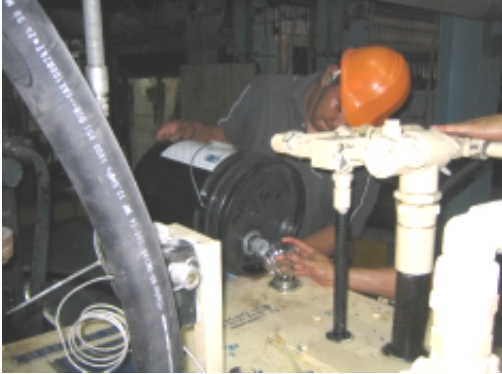
Figure 1

On Feb. 4, 2004 the system was chemically cleaned by adding a special solvent to the oil, which would quickly remove interior varnish from the system.

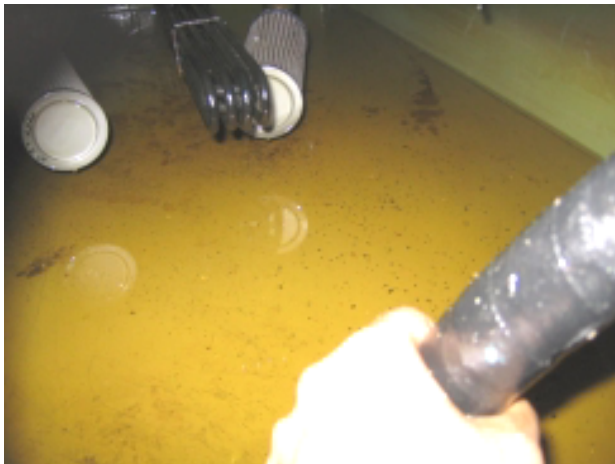
This is evidenced by the quantity of particles found on the bottom of the tank and collected in the filters of the system after they were taken off when the system was drained. See Figure 3 and 4.

At this point it is valid to mention that the ideal recirculation of the solvent is 40 hours. Had the system reached this time, the amount of removed particles would have been much greater. The 40 hours could not be reached because the production had an approximate 24 hours of scheduled shut-down only.

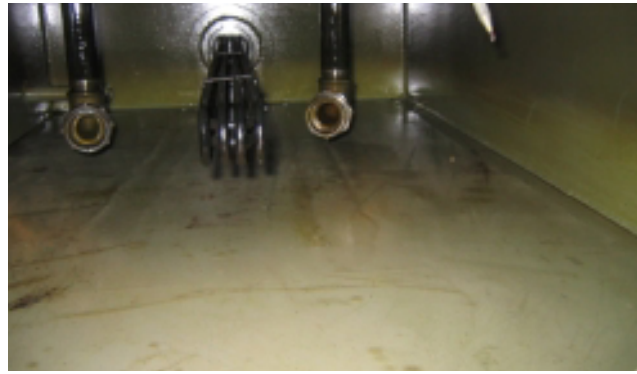
Additionally, in Figure 5 we see the state of cleanliness of the tank of the system, which was manually cleaned, and then changed to the hydro fractioned oil.

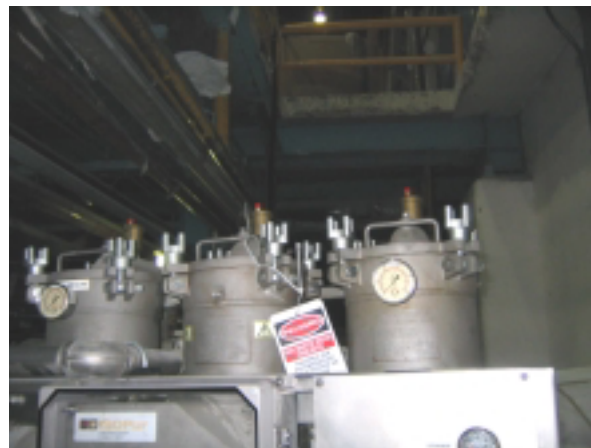
Figure 6

Once the oil tank was cleaned and the filters were replaced the new oil change was started. The ISOPur equipment was used to filter the oil as it entered the system, which guaranteed an additional cleaning measure. See Figure 6.

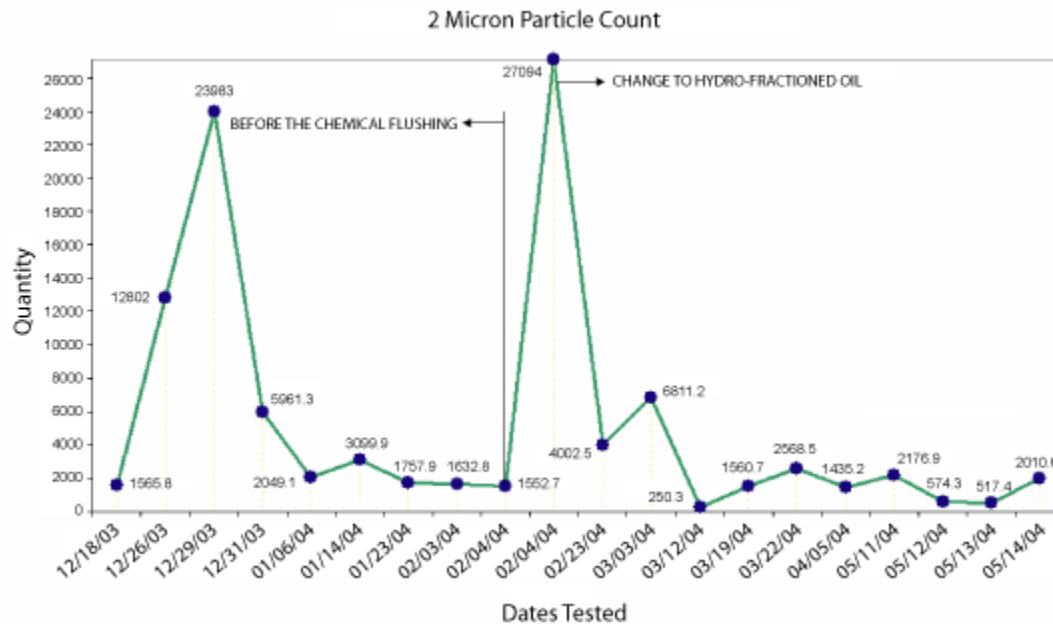
Graph 2 - Two micron particles

In Graphs 2, 3 and 4 represent the number of particles measuring 2, 5 and 15 microns per ml of oil present in the system. As we can see, the tendency is the same as the ISO code from Graph 1. At first, high values were obtained when the ISOPur equipment was connected but they then reduce as a result of the equipment operation. The rise is then due to the chemical cleaning. Finally, the general tendency is decreasing and the number of particles lowers with time.

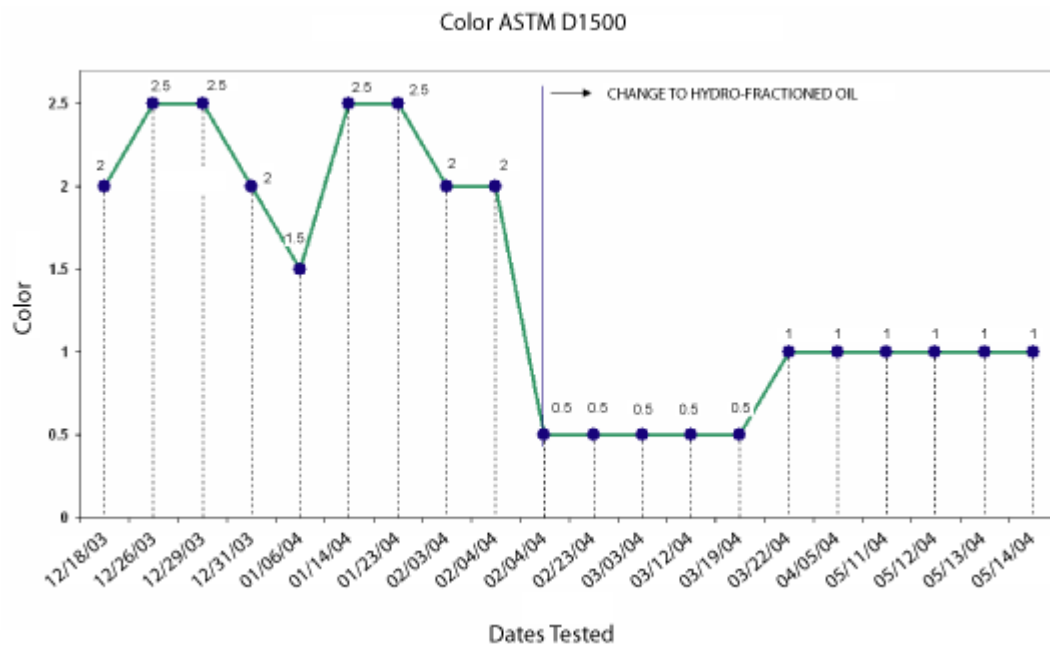
Graph 5 - Color ASTM D1500

Graph 5 shows the oil color. We can easily see the amazing change of homogeneity, color and thus its purity when changed to the hydro fractioned. A faintly lighter color is apparent, from 0.5 to 1.0 which is very plausible since this is the first change to the hydro fractioned oil as well as use of the ISOPur cleaning process. With future changes of hydro fractioned oil, the color of the oil will continue to stabilize.

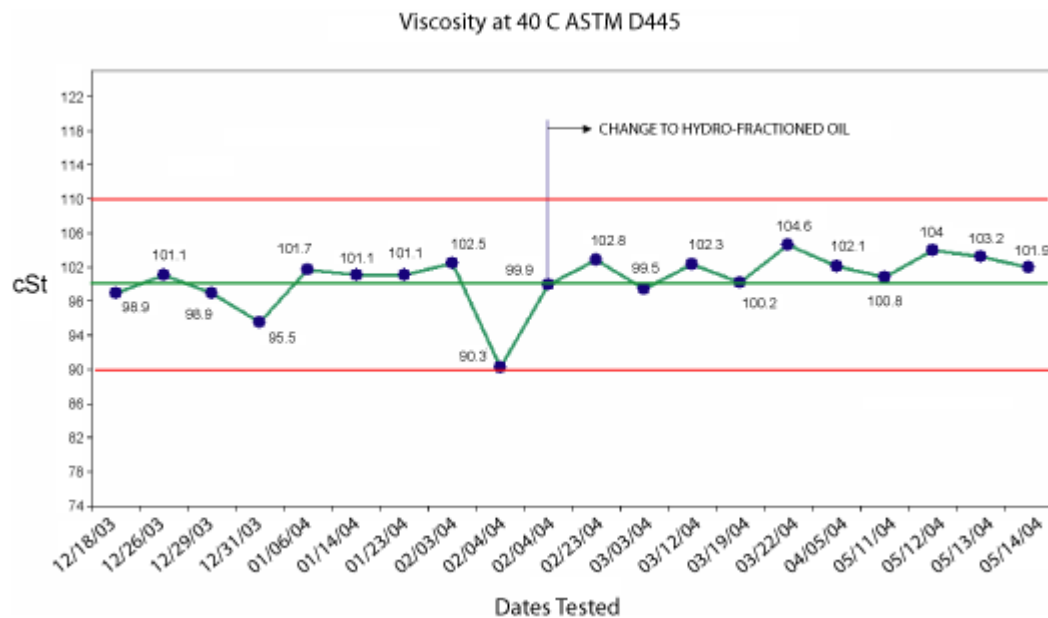
Graph 6 - Viscosity at 40 degrees C ASTM D445

The viscosity of the old oil in the Industrial Paper Machine #4 represented one of the biggest operative issues, because of the tendency to notably decrease to the point of the hydraulic pressure not reaching operational levels. In the case of the hydro fractioned oil, a stable viscosity was always above 100 cSt., which guaranteed an adequate thickness of lubricant at all times. This is attributed to the higher resistance to changes in viscosity resulting from thermal changes. The hydro fractioned oil has a higher viscosity index. See Graph 6.

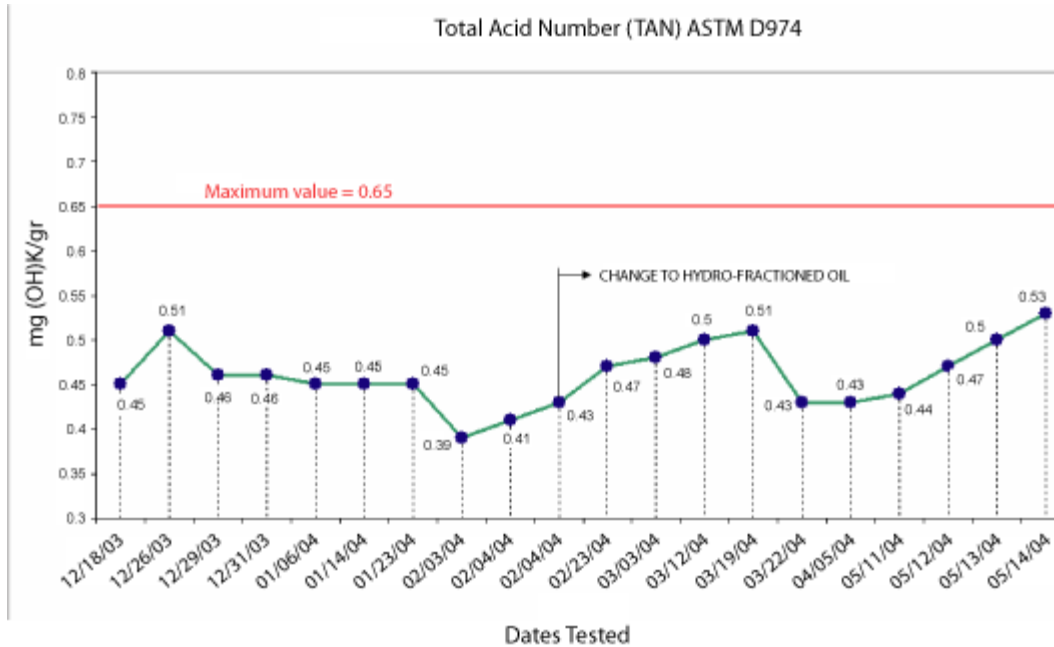
Graph 7 - Total Acid Number (TAN) ASTM D974

In this respect, the TAN value is kept under the recommended values. Note that some hydraulic oils, like those for gears, have special additives, such as AW (anti-wear) and EP (extreme pressure). These present much higher TAN values than the turbine oils, for instance. This is normal since the chemical nature of the anti-wear components (like phosphorus and sulfur) is capable of oxidizing and forming acidic components. See Graph 7.

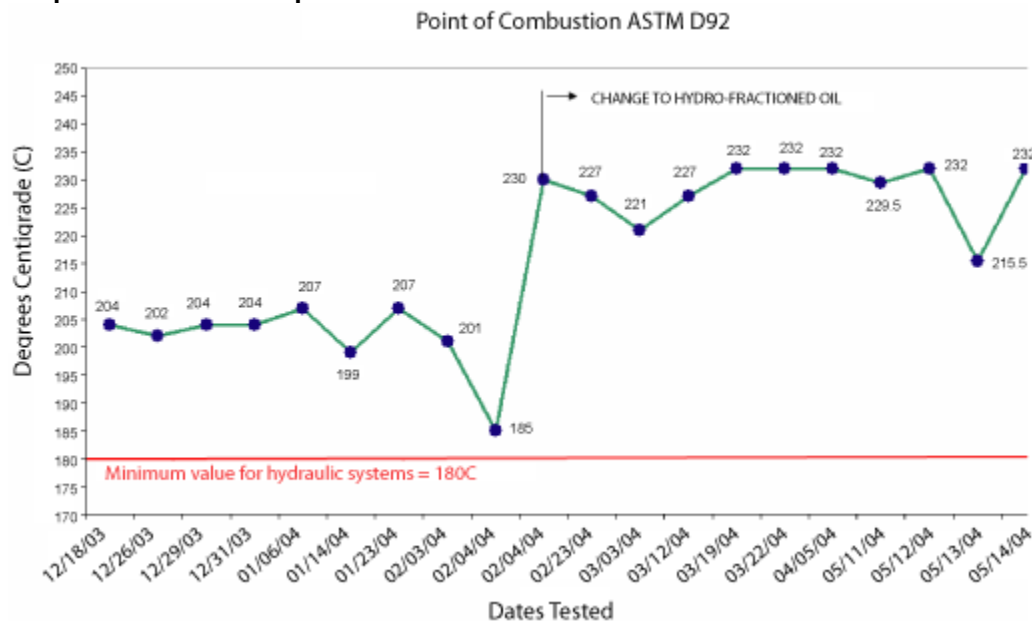
Graph 8 - Combustion point ASTM D92

Solvents are the notable difference between hydro fractionated and refined oils. This property is especially important in high temperature applications. See Graph 8.

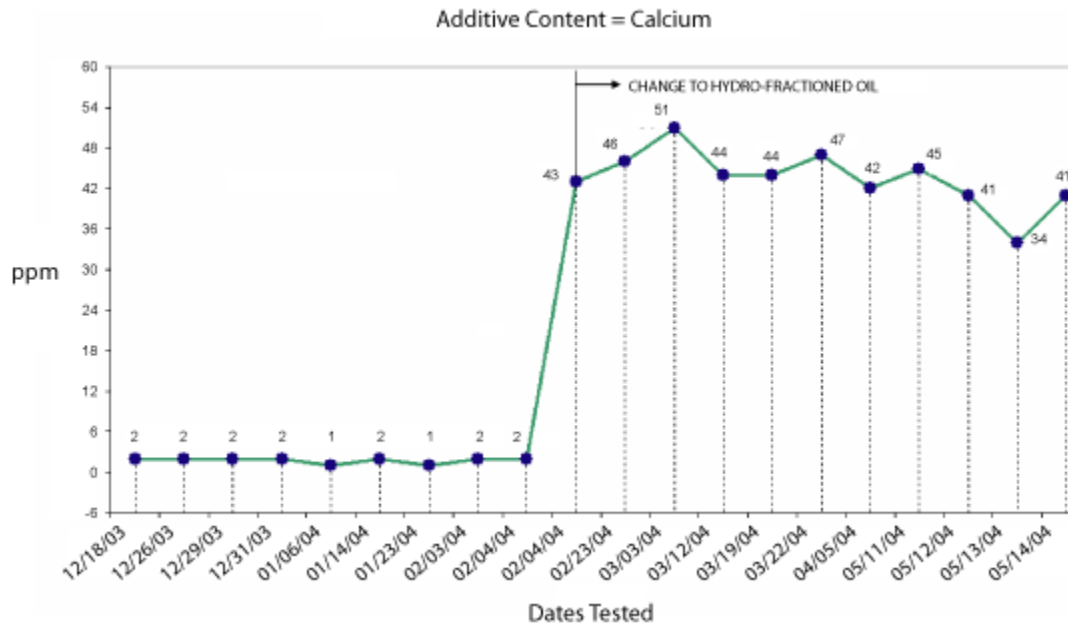
Graph 9 - Content of Additive: CALCIUM

The strong additive pack and purity of the hydro fractioned oil generates less undesirable reactions due to its higher receptivity.

This benefit translates into a longer life for the machine and for the lubricant because of its higher resistance to oxidation and to the formation of varnish. See Graph 9, 10 and 11.
